**SITE INSPECTION REPORT
UPPER MOUNTAIN ROAD
738 UPPER MOUNTAIN ROAD
LEWISTON, NIAGARA COUNTY, NEW YORK**

EPA ID No.: NYN000206697

June 2014

Weston Solutions, Inc.
Edison, New Jersey 08837

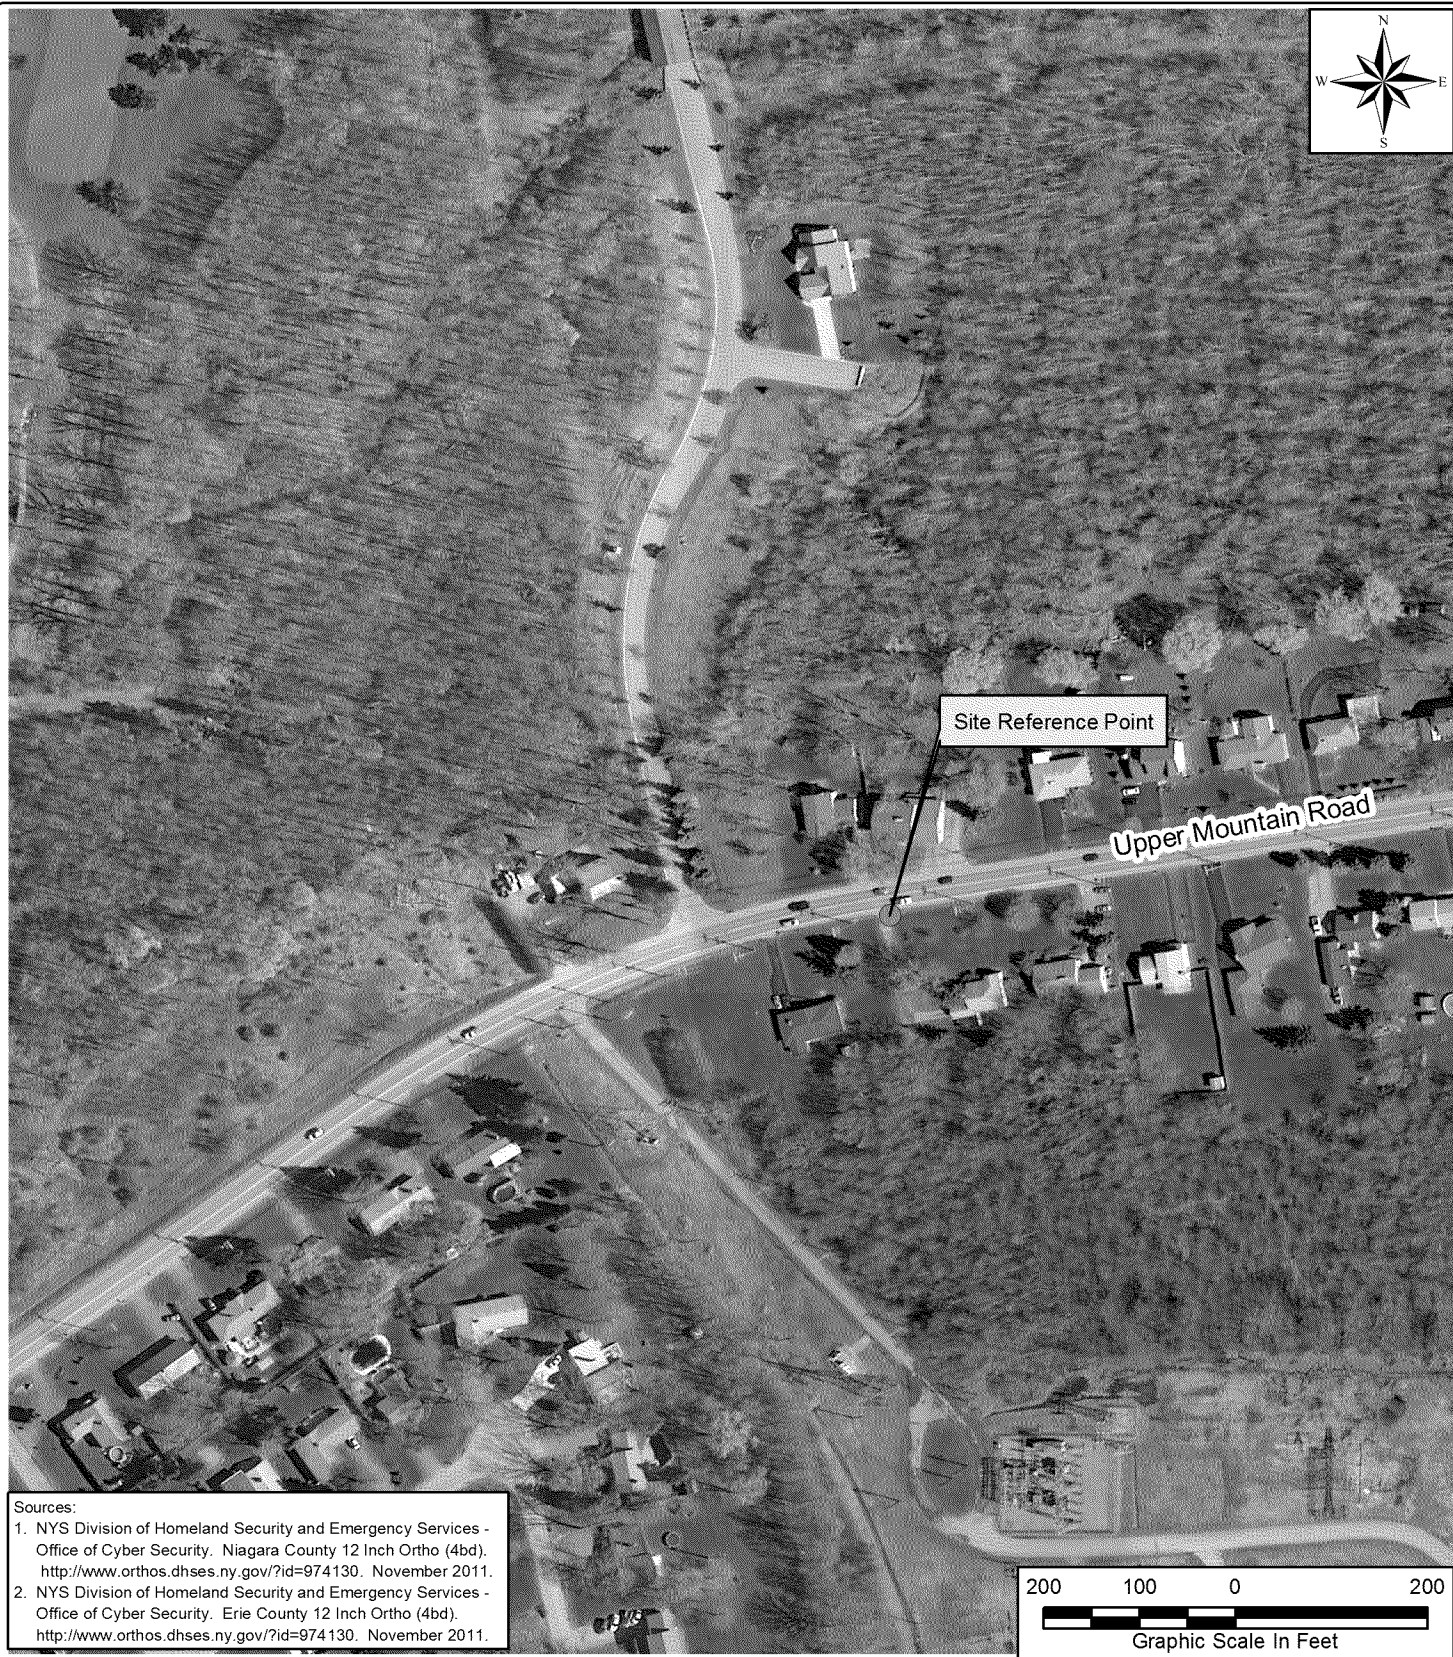
The UMR site is bordered to the north by Upper Mountain Road, residential properties, and a further wooded area; to the east and west by residential properties; and to the south by a wooded area [Ref. 2, Figure 2; 10, p. 3]. A Site Location Map and Site Map are included as Figures 1 and 2 of this report.

Site Map
Upper Mountain Road
Lewiston, NY
